Troubleshooting Profibus PA

A practical example

James Powell, P.Eng.

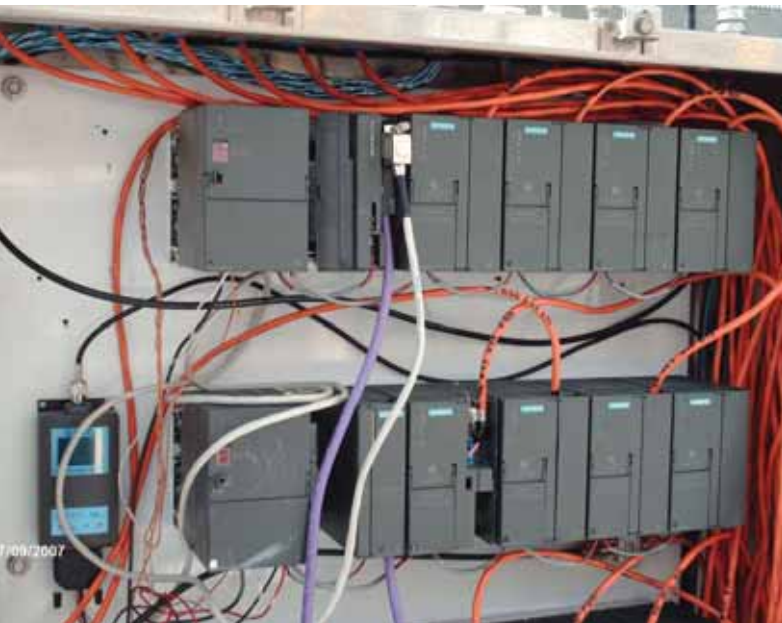
The visual inspection proved to provide the most information. Technically, at installation several Profibus DP wiring guidelines were violated by mixing cable types, and not using powered terminators (see Figure 3). However, the network was running at 9600 baud and the copper wires were going less than 100 meters, which meant that these violations would have had no impact on the error rate. Also during the visual inspection, we noticed that a couple of the

Figure 3: One of the panels shows violation of Profibus DP wiring guidelines

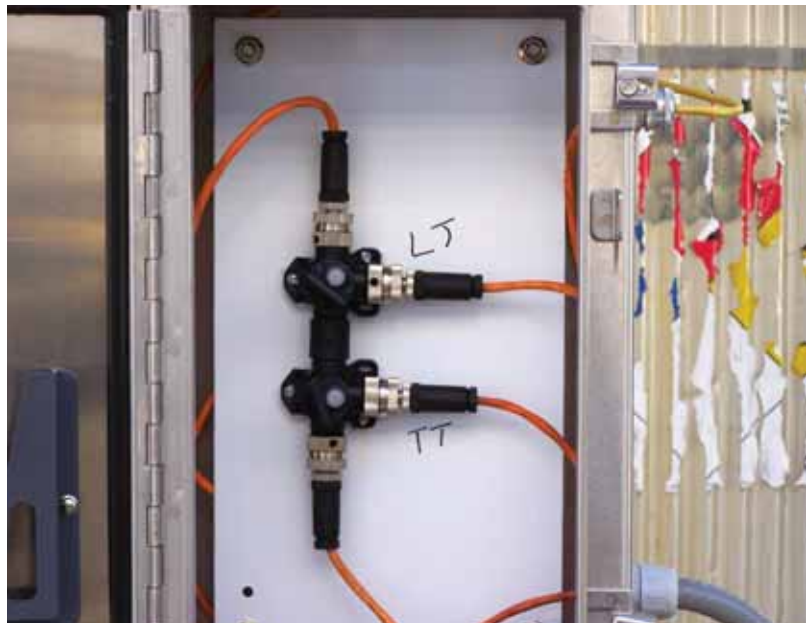
Figure 7: "T" connector junction box with M12 connectors

We found the answer at the T-connectors and cable types that had been mixed (Figure 7). The site was using Siemens T-connectors and Belden Profibus PA cable. The Siemens T-connectors are vampire type connectors and are designed to match the impedance of the Siemens Profibus PA cable. The IEC 61158-2 standard does not state an exact specification for class A cable. It states a range. Therefore one manufacturer will pick one set of values and another vendor will pick another. When you mix cable types, you get reflections similar to what you get when you are missing a terminator; only to a lesser degree. In this case, the site was unknowingly mixing cable types. We concluded that given the size of their wire runs, this was not a problem for communications; the bus monitor sup-

ported this. Had this been a non-IS environment with long wire runs, then this wire practice would have been a problem. The ultimate solution would have been to switch out the T-connectors for Profibus PA junction boxes.

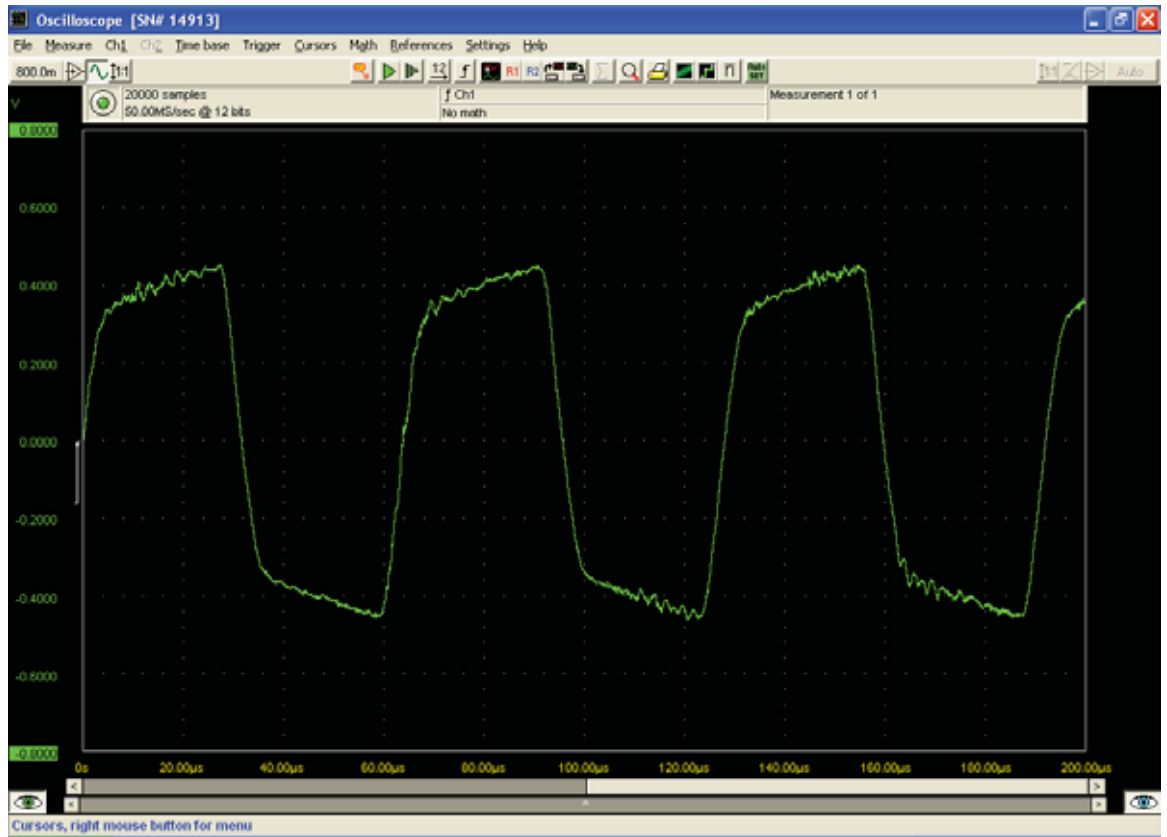
Figure 4 shows the waveforms from segment 2, which with its angled peaks and valleys shows there is a problem. Figure 5 shows an ideal wave form in Profibus PA. Figure 6 shows the waveform of a short run with no terminator.

We call this a problem in the sense that the waveform is not consistent with the ideal waveform; the peak to peak voltage is too high and the peaks and valleys are distorted. When we attached the bus monitor to the segment, we saw zero retries and zero errors on this segment. All the instruments were properly functioning, but we were not content with the overall result. We were also getting a similar waveform from most of the other segments, many of which were having communication problems. Something was not right.

In the case of segment 2, the waveform peak to peak is over 800mV. The distortion at the top and bottom is similar to a segment that is missing a terminator. Just looking at the waveform, we thought that we were examining a long run with a missing terminator. However, the run was under 500 meters, which is not that long; so what else could be causing that level of distortion?

Figure 4: Segment 2 waveform; the angled peaks and valleys indicate problems.

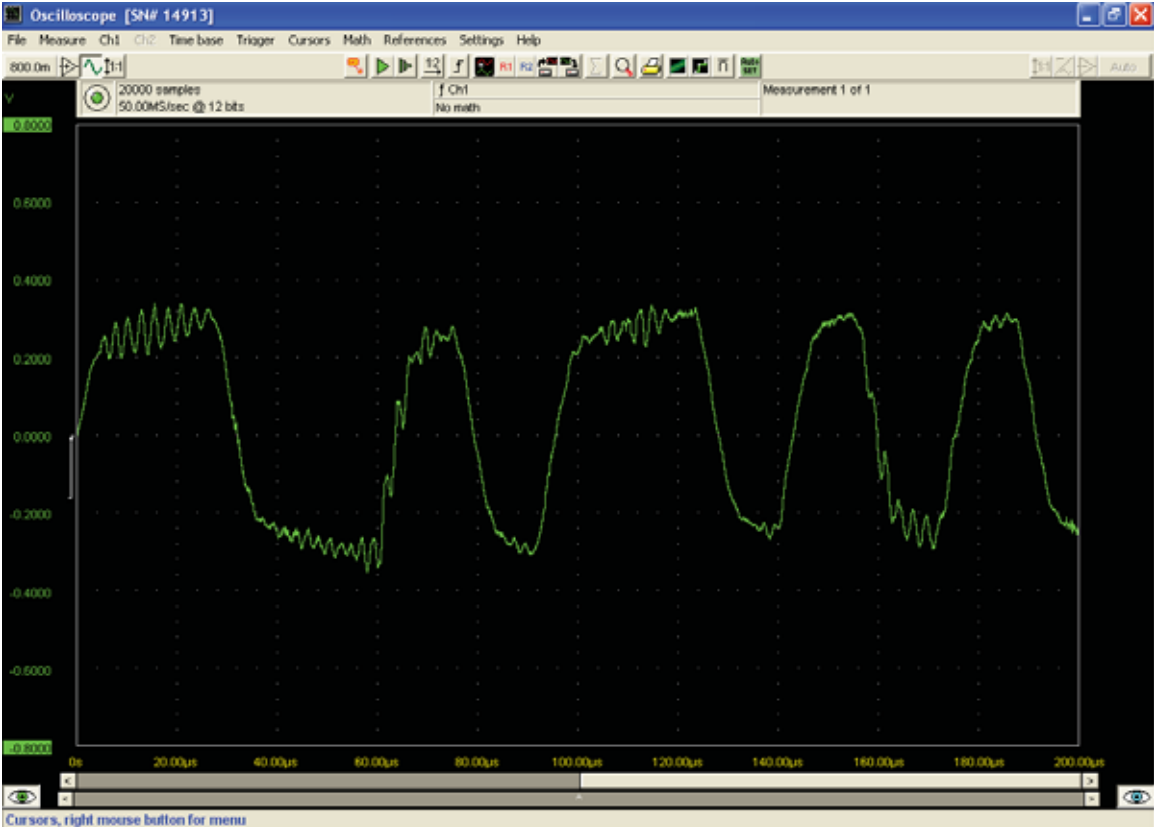
Fig. 8: Segment 1.

Figure 8 shows the waveform from segment 1.

When we looked at this, we figured that there were interferences from power cables or Variable Frequency Drives (VFD). However, when we traced the wire runs, we could not find any sources for electrical noise. During our wire tracing procedure, we opened the cabinets that held the T-connectors with the M12 connectors. These cabinets were not sealed correctly and had water dripping from the M12 connectors (Figure 7). Also, the M12 connectors were connected with only a half turn. A tight connection requires several complete turns, and these connectors were just barely touching. After we dried tightened the connectors the waveform cleaned up.

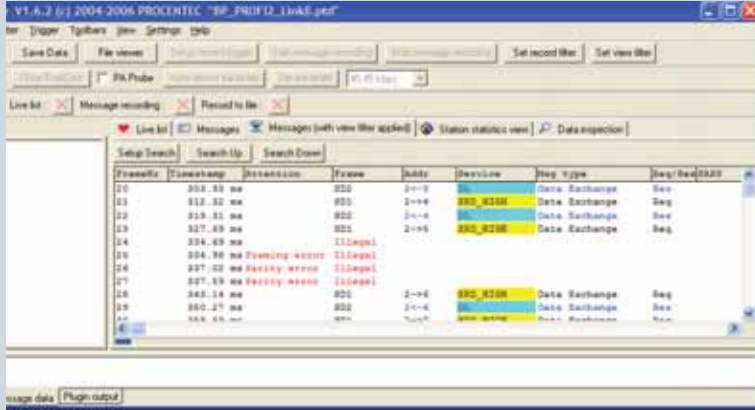
Fig. 9: Trace from Segment 1: showing framing errors and illegal messages

On this same segment, we were also having trouble communicating to a Siemens radar level transmitter (Sitrans LR250). We connected the Profibus bus monitor program and saw Figure 9. Given the waveform shown in figure 8,

it was natural to assume that it was the electrical noise that was causing this problem. However, once we solved that problem by drying the connectors and tightening them, the communication problem with the Sitrans LR250 did not correct it self. From prior experience, we know that another cause of the framing errors and illegal messages could be two devices with the same address. So we went up to each field device and verified the address. We found two devices with the same address. The solution was simple to change the address in one of the devices to the address that it was supposed to have. Once we did this, the bus errors disappeared.

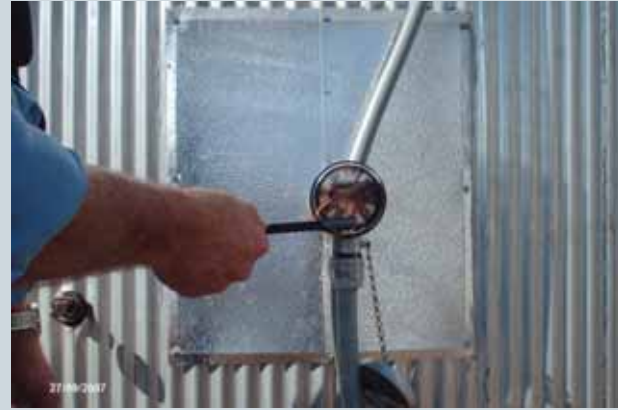
Fig. 10: Temperature transmitter incased in water

On segment 10, we had the power light on the Profibus DP/PA Coupler blinking. Since we had only ever seen this light as a solid green, we checked the manual. The manual said that this indicated that the segment was drawing too much power and the current was being limited. On this segment we had a number of Sitrans LR250 level and Sitrans TH400 temperature transmitters. We were communicating to the level devices but had lost communications to some of the temperature transmitters. Therefore, we thought we were probably dealing with an overloaded segment – too many devices and/or too long.

transmitters, water started to shot out from around the seal and we saw what the problem was (Figure 11). The unit was installed correctly except that where the conduit ended it was not sealed (Figure 12). Water collected via the conduit until the temperature transmitter was completely under water.

To our amazement we could still communicate to all the radar devices on this segment and it was in full data exchange. When we tried to do a download with Simatic PDM, we received communications errors on the long messages, but given that several of the instruments were underwater, we would not have expected any communications at all.

These were also the instruments that the customer was reporting losing connection with – not a big surprise. Once the instruments that were underwater were replaced and the conduits were properly sealed, this problem disappeared.

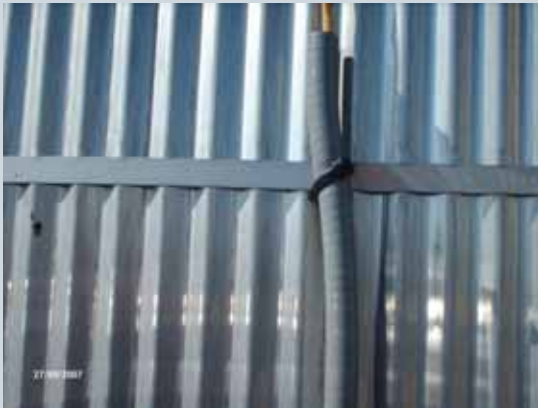
Fig. 11: Conduit open at the top for rain
