Troubleshooting Profibus PA

A practical example

James Powell, P.Eng.

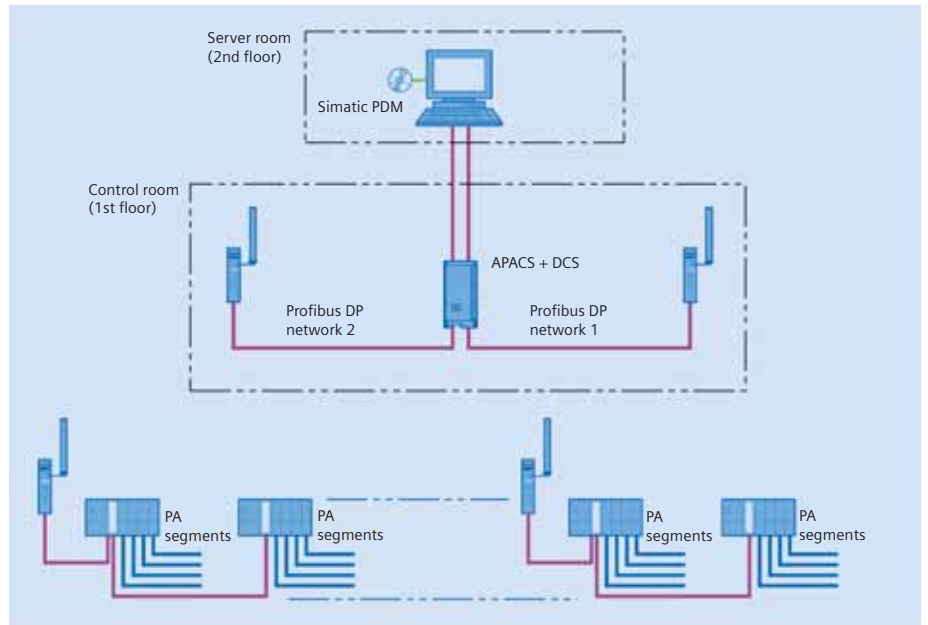
The layout of the two networks is shown in the Figure 1.

Figure 1: The control system includes two Profibus DP networks with a Siemens APACS DCS

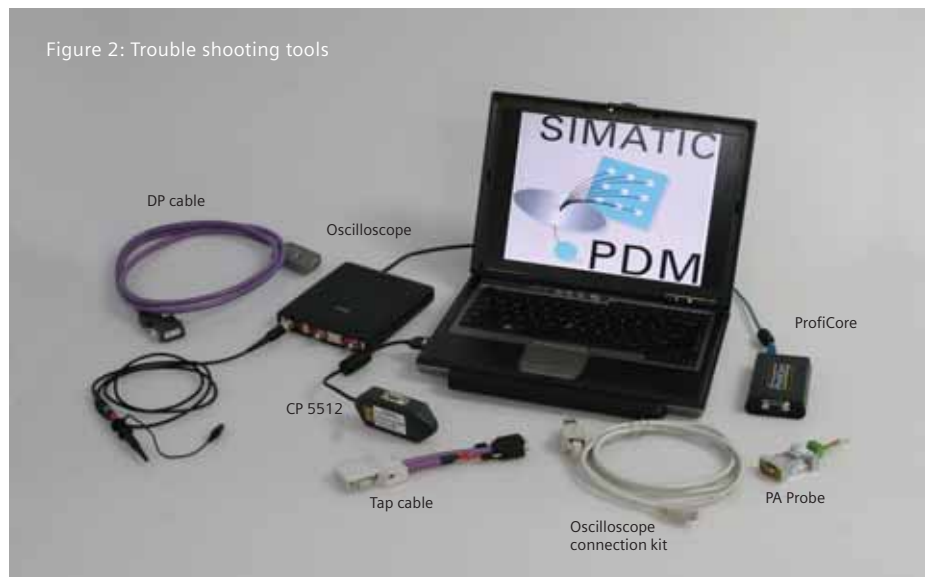
Before you can troubleshoot a network, you need the correct tools (Figure2). The two key tools for Profibus are a bus analyzer and an oscilloscope. We used a Profibus bus monitor called ProfiTrace which has a special PA probe so that you can view the messages right on the Profibus PA side of the network. For troubleshooting, we used a low cost USB oscilloscope which worked well for this purpose. The oscilloscope is useful because you can get a lot of information from looking at the Profibus PA waveform.

Figure 2: Trouble shooting tools

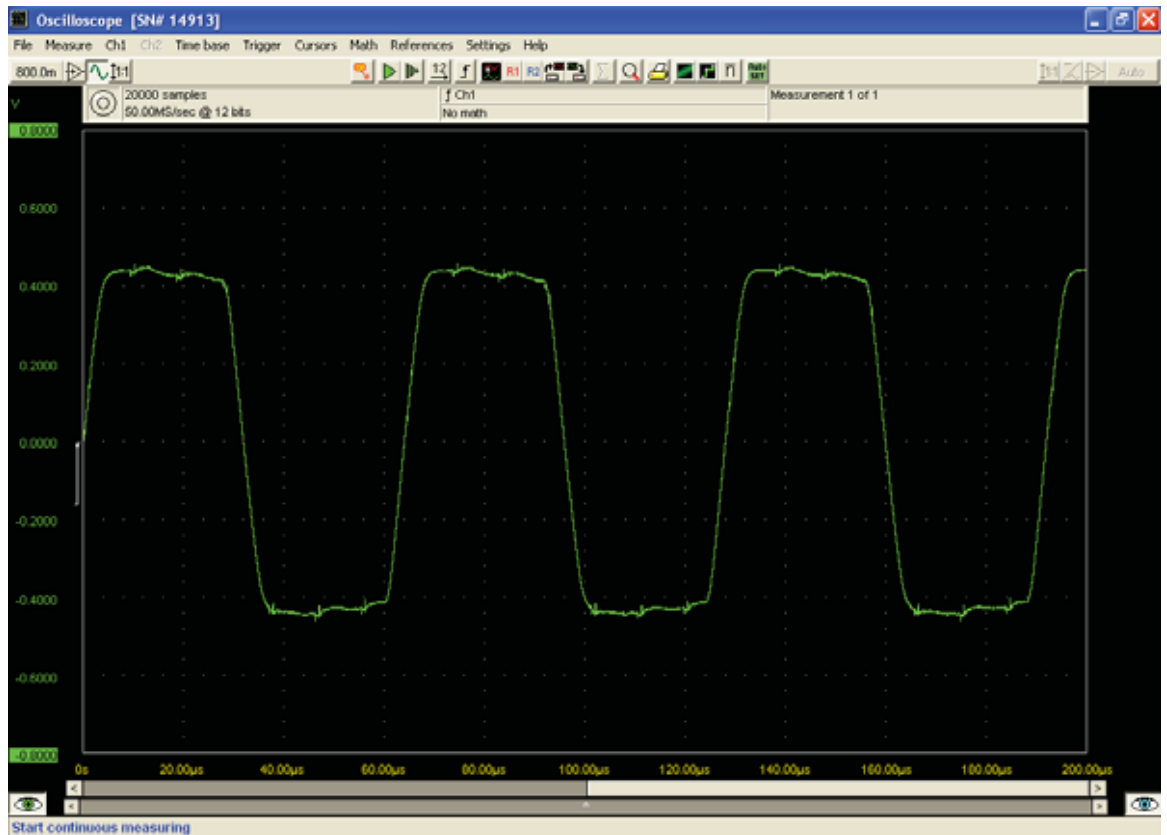
An ideal waveform has a peak to peak voltage of around 800mV (Figure 5). If you are missing a terminator, then you get a peak to peak voltage of around 1.5 V and distortions at the top and bottom (Figure 6). Also, as you increase the size of the network, the peak to peak voltage is lowered.

Figure 5: Ideal wave form; a symmetrical form shows perfect communication of signals.

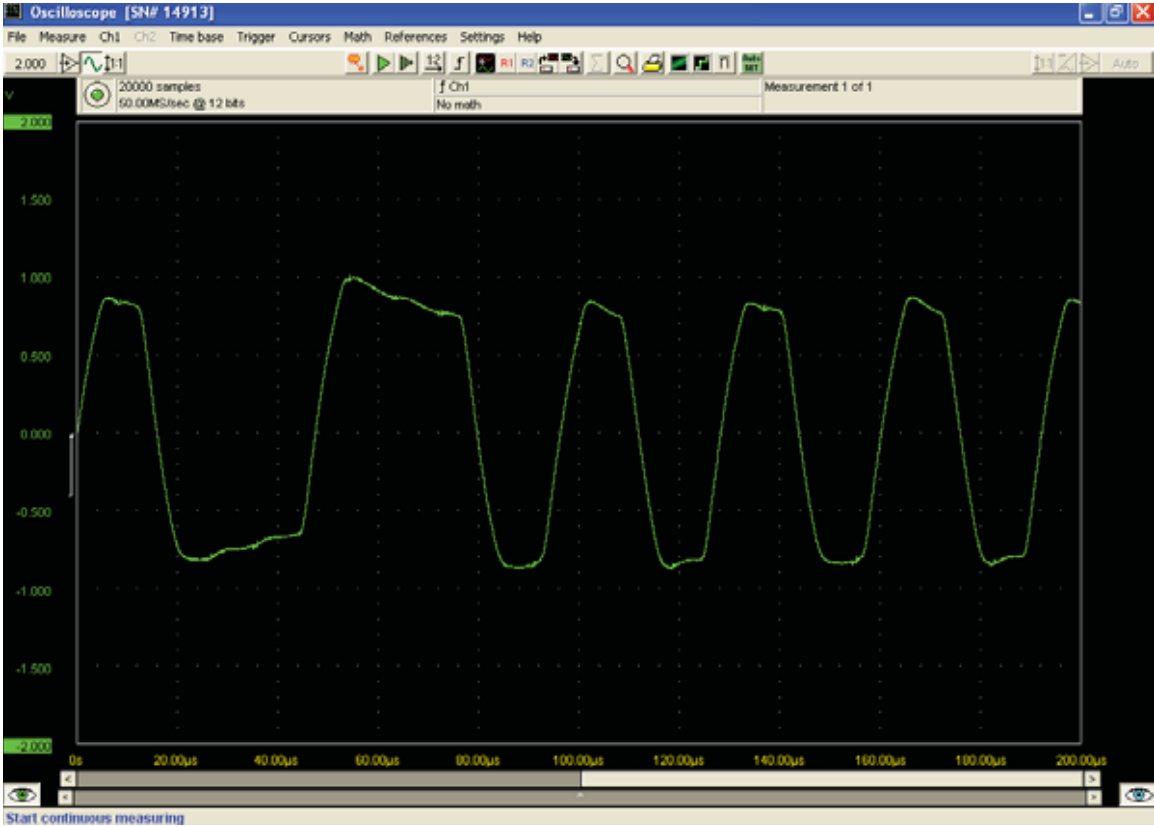
In the case of segment 2, the waveform peak to peak is over 800mV. The distortion at the top and bottom is similar to a segment that is missing a terminator. Just looking at the waveform, we thought that we were examining a long run with a missing terminator. However, the run was under 500 meters, which is not that long; so what else could be causing that level of distortion?

Figure 6: Waveform when missing one terminator.
